Three-Dimensional Digital Image Correlation of a Composite Overwrapped Pressure Vessel During Hydrostatic Pressure Tests

Ambient temperature hydrostatic pressurization tests were conducted on a composite overwrapped pressure vessel (COPV) to understand the fiber stresses in COPV components. Two three-dimensional digital image correlation systems with high speed cameras were used in the evaluation to provide full field displacement and strain data for each pressurization test. A few of the key findings will be discussed including how the principal strains provided better insight into system behavior than traditional gauges, a high localized strain that was measured where gages were not present and the challenges of measuring curved surfaces with the use of a 1.25 in. thick layered polycarbonate panel that protected the cameras.

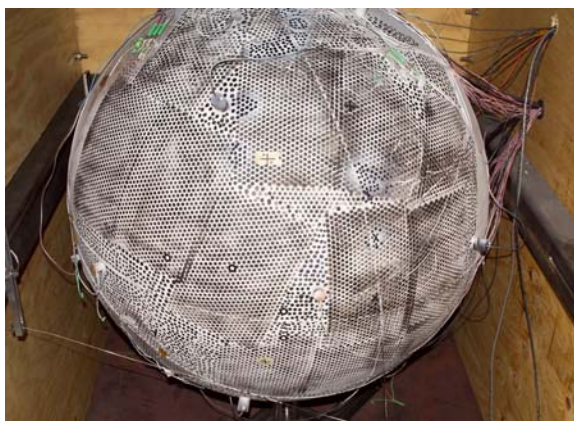
Figure 2.—COPV dot pattern painted on vessel for digital image correlation.

The DIC system used in this test program was developed by GOM mbh of Braunschweig, Germany and utilizes a software package called ARAMIS. The ARAMIS software uses principles of three-dimensional image correlation photogrammetry that gives full-field displacement and strain measurements. The system requires spraying random high contrast dot patterns onto a sample; this pattern is then tracked in ARAMIS by thousands of unique correlation areas known as facets. The center of each facet is a measurement point that can be thought of as a three-dimensional extensometer. Arrays of them form in-plane strain rosettes. The facet centers are tracked in each successive pair of images, with accuracy up to one hundredth of a pixel. Figure 2 shows a 3/8 in. dot pattern used on the 40 in. vessel.

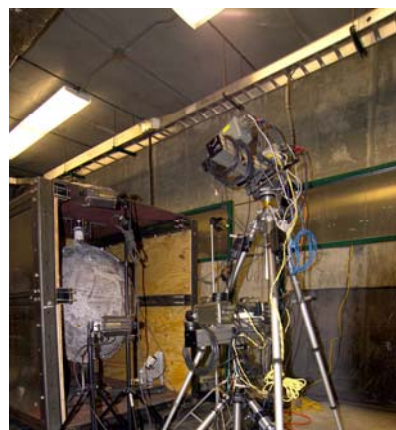
Figure 3.—Three-dimensional digital image correlation system setup.

Two three-dimensional digital image correlation systems with Phantom v7.0 high speed cameras (Vision Research Corp. Wayne, NJ) were used in the tests, one focusing on the upper boss area and the other on the equator of the vessel (fig. 3). The high speed cameras are not standard with the DIC system but have been validated by the NASA Glenn Ballistic Impact lab during impact test studies for the Space Shuttle Program after the Columbia Accident (refs. 10 to 12). The digital high-speed cameras were used at a resolution of 512 by 512 pixels giving a recording speed range between 100 to 8,000 frames per second. The Phantom cameras act as a stereo pair to create a volume of area in which the ARAMIS software can take measurements. This volume varies with the angle of the cameras and lens choice. Camera setup consisted of 16-mm lenses with the cameras angled at 15.3° , giving a measuring volume of 1060 mm/875 mm/875 mm. To calibrate for this volume, the camera resolution was set at 800 by 600 pixels and a 1200-mm NIST-traceable calibration cross was rotated and moved in specified locations to calibrate the sensor. The cameras used IRIG time for synchronization, which provided accuracy within $1\ \mu\text{s}$ between images. Each DIC system was able to solve approximately $70\ \text{in.}^2$ of area on the vessel. Both DIC systems were used at WSTF during all of the pressurization cycles. The 40 in. COPV was filled with water and pressurized at 5 psi/sec and at 50 psi/sec to its proof pressure, at 50 psi/sec to its maximum operating pressure, and at 50 psi/sec to burst.
